SEWER SYSTEM EVALUATION STUDY GWYNNNS FALLS SEWERSHED STUDY AND PLAN

4.0 Sewer System Evaluation Study

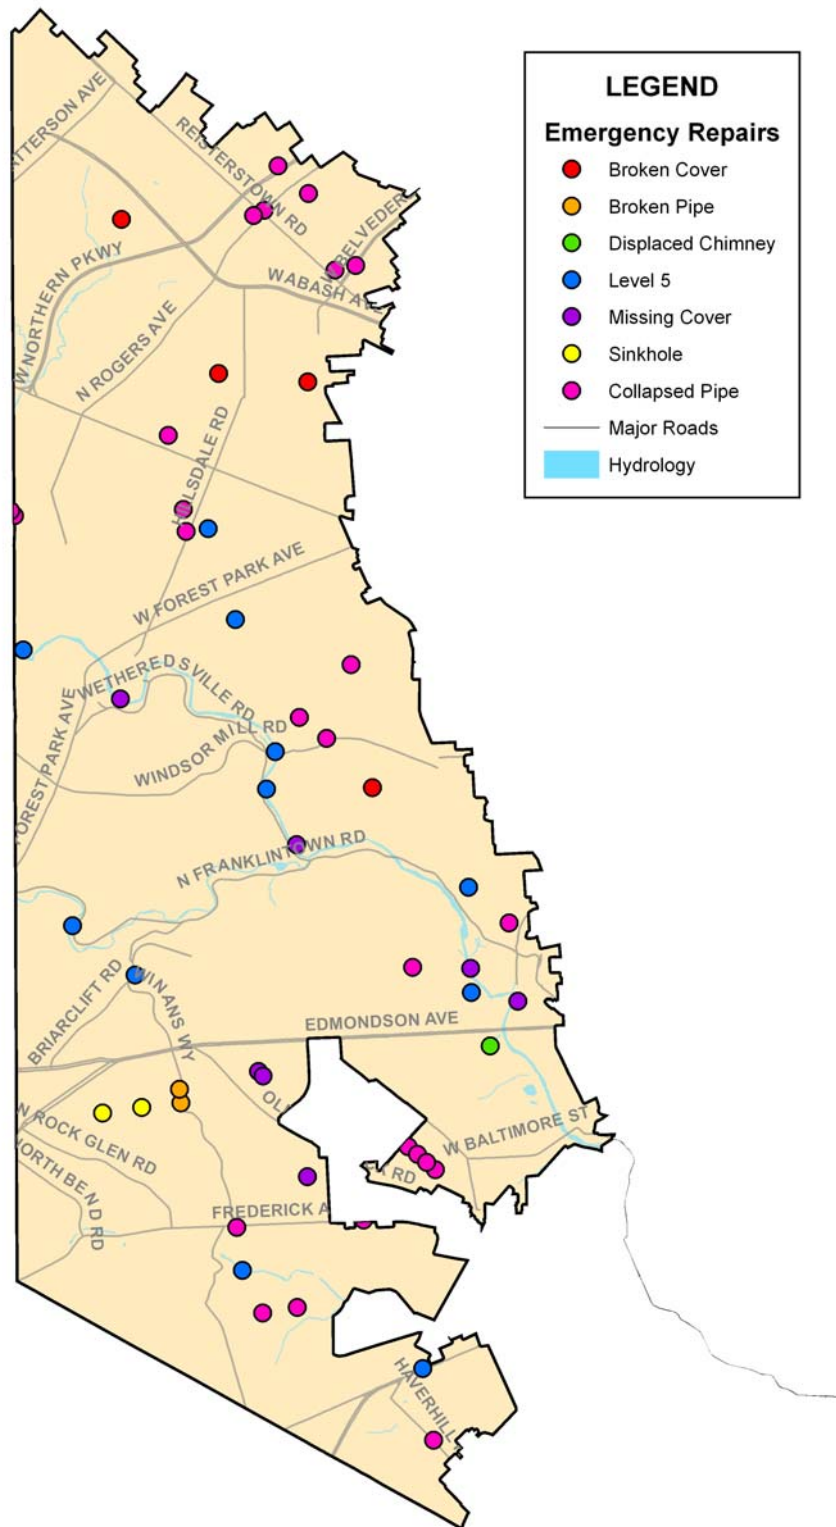
Figure 4.6.1 – Emergency Repair/Rehabilitation Locations

In accordance with Paragraph 9 Item C.iii of the Consent Decree, all significant system deficiencies observed during field inspections or when reviewing the field data were reported to the City through the established Consent Decree communication protocols. In some cases the City's non-emergency assistance hotline (311) was also contacted. Figure 4.6.1 indicates the location of reported observed significant deficiencies.
